Recommendations
to improve
the safety of
existing lifts

Lift safety

Lift & Escalator Industry Association

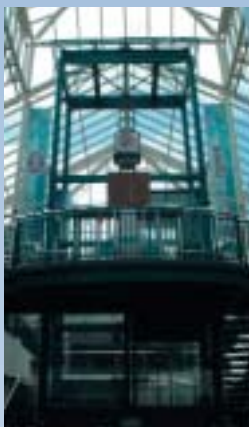
No. 3 on Safety Checklist

Levelling Accuracy

Inaccurate or inconsistent floor levelling is not merely an inconvenience, it is potentially hazardous, particularly for the infirm or partially sighted. It is doubted if the levelling accuracy of many older lifts would be deemed acceptable by today's standards. Modern technology can significantly reduce the risk of tripping by greatly improving floor levelling.

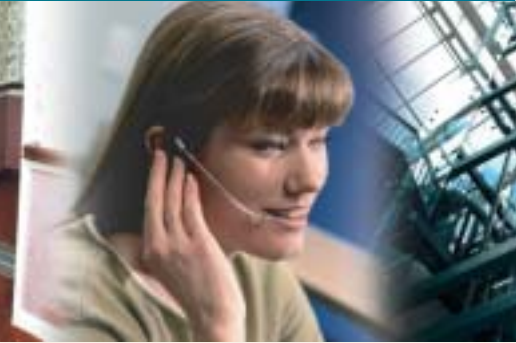
No. 71 on Safety Checklist

Communication

In order to ensure that passengers who may become trapped in the lift car have contact with the outside world, the law, since 1999, has required that for new lifts the lift car be fitted with a (24 hour) two-way means of communication allowing permanent contact with a rescue service. This provision is equally valid for older lifts.

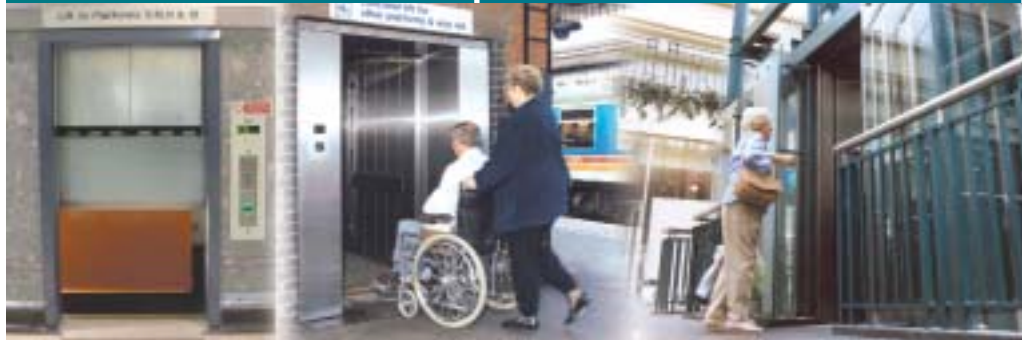
No. 39 on Safety Checklist

Car Apron

For the safe release of passengers in an emergency, and in order to ensure against the risk of falling into the lift well when the car and landing doors have been opened, the car sill should be fitted with an apron.

| 39 | <input type="checkbox"/> | Inadequate length of car apron | | | |

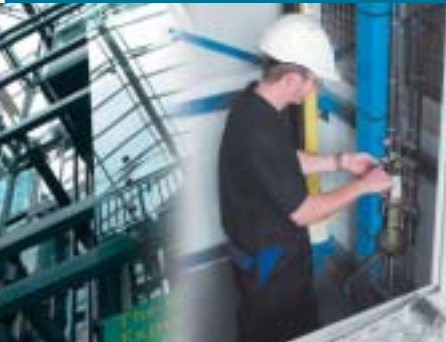
No. 14 on Safety Checklist

Safe Working Space

With the enforcement of the Lifts Regulations since 1999 it has become essential for new lifts to provide a working space at the top and bottom of the lift well in order to create a safe refuge. Where such space is not available, or a safe system of work cannot be put in place, a full maintenance/inspection may not be possible. The particular emphasis on this issue results from a number of fatal accidents.

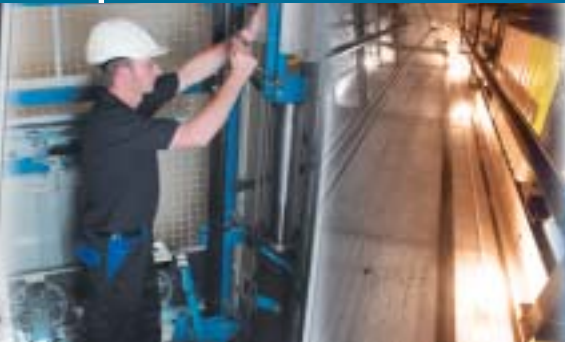
No. 17 on Safety Checklist

Well lighting

No longer is it considered sufficient to use hand-held or temporary lighting when working within an enclosed lift well. There now exist prescribed levels of lighting intensity sufficient to illuminate the work area.

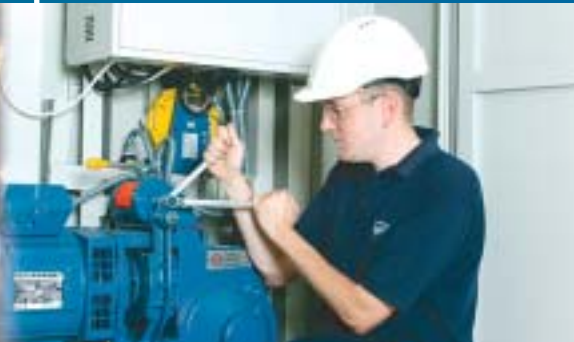
No. 19 on Safety Checklist

Access to Machinery Room

Safe means of access (and egress) to the lift machine and pulley rooms is essential not only for maintenance/inspection but also the release of passengers who may become trapped in the lift car. Access should ideally be via a permanent staircase. Where this is not possible alternative routes must be safe, unobstructed and well lit.

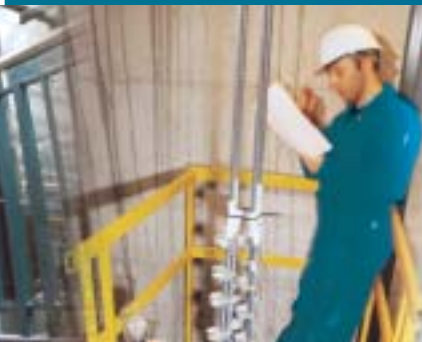
No. 43 on Safety Checklist

Voids

Current requirements call for the fitting of a balustrade on the car roof as protection against the risk of falling into the lift well. This was not always a requirement even though with many existing lifts there are large gaps between the car and the wall of the well which present a risk of falling. A guard is strongly recommended in BS7255 'Safe working on Lifts'.

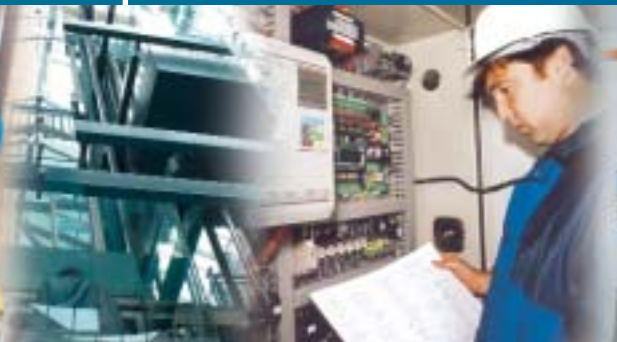
Nos. 66 & 68 on Safety Checklist

Electrical Protection

To avoid the risk of electric shock live terminals should be shielded and all high voltage terminals clearly marked. In most cases there should be a warning to indicate that voltage may be present even when the supply is switched off. The main switch shall be capable of being locked-off.

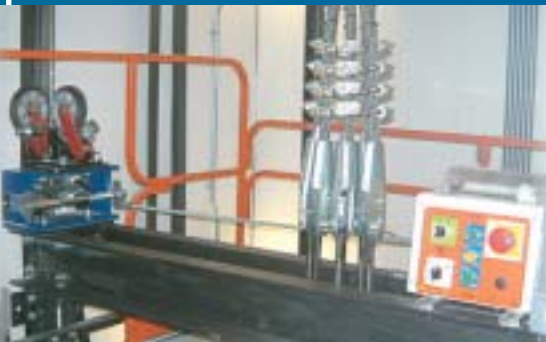
No. 70 on Safety Checklist

Inspection Control

Strict procedures need to be in place when working on the top of a lift car, particularly when the car is to be moved, which is often necessary for maintenance/inspection. This is a high risk area and inadequate provisions have resulted in serious injury and death. It is for this reason BS7255 'Safe Working on Lifts' strongly recommends that on existing lifts there shall be provided an appropriate control. This is a recommendation endorsed by the Health and Safety Executive.
